# Introduction

This a Case Study where one of their vehicles was driven in with a “Runs Rough” complaint. Which after further inspection, turned out to be more catastrophic than anticipated.

# Cylinder Head Crack

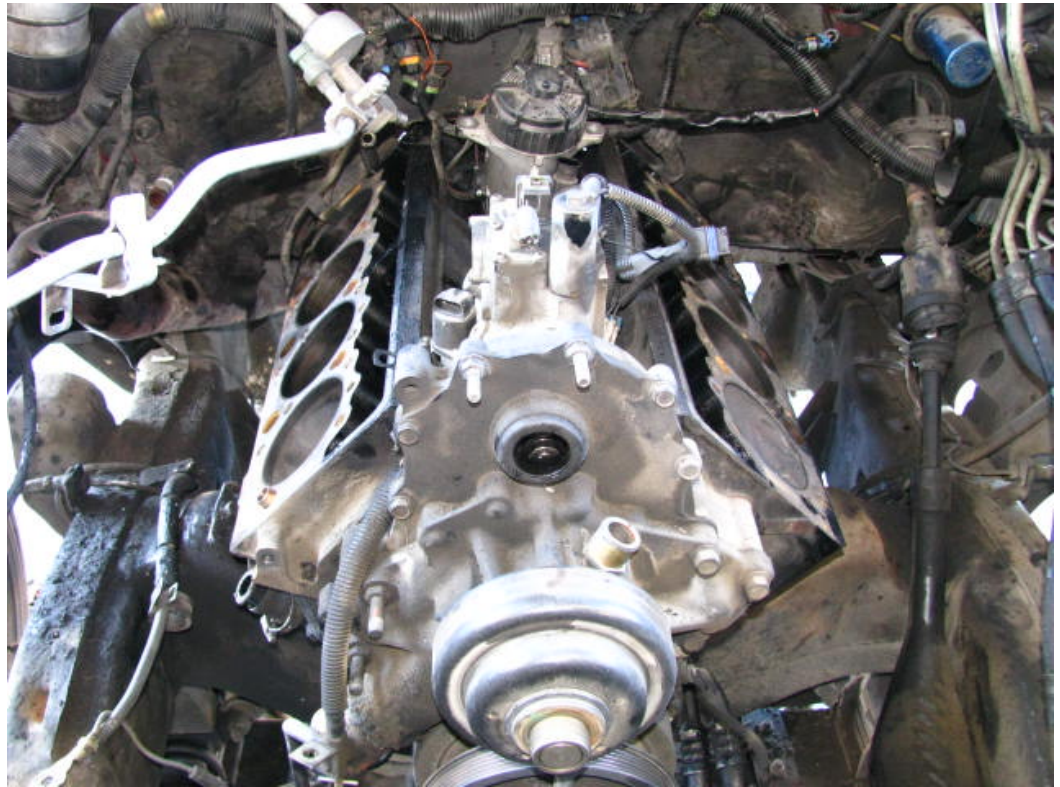
This unit had approx. 50,000 miles on it when we started using the ProOne products. On initial inspection we found a dead miss in the right bank, pulled a glow plug and performed a cylinder leak down test.

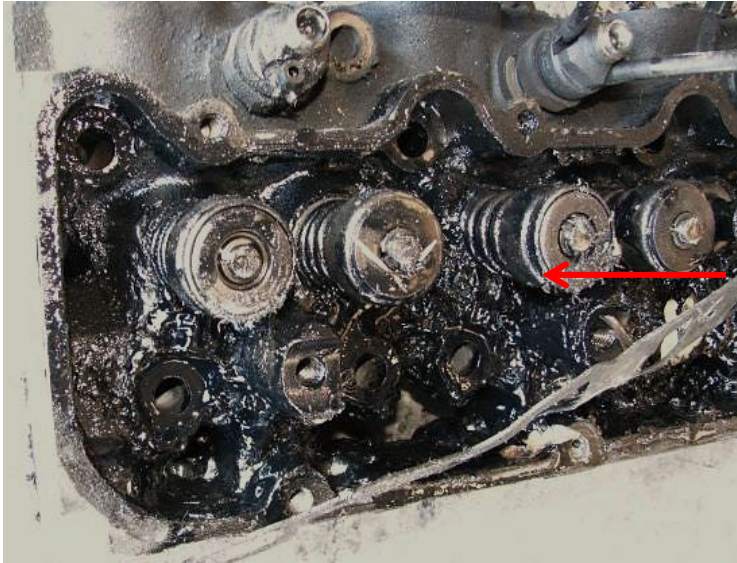
Cylinder heads are prone to cracking between the valve seats. This is usually caught by a competent operator as they will report loss of coolant with no apparent visual leak.

If this condition is not corrected, the coolant level will continue to drop and severe overheating will occur. If the leak is large enough, when the engine is switched off, the pressure in the cooling system will fill up the cylinders where any head cracks are with water.

This engine was ran for an undetermined amount of time with a cracked head issue until it obviously got to the point of a major failure. As the coolant and engine oil mixed, it congealed making a thick goo of a greasy mess. Normally, this situation breaks down the lubricating properties and film strength of the engine oil, causing bearings and piston skirts to gall and weld together.

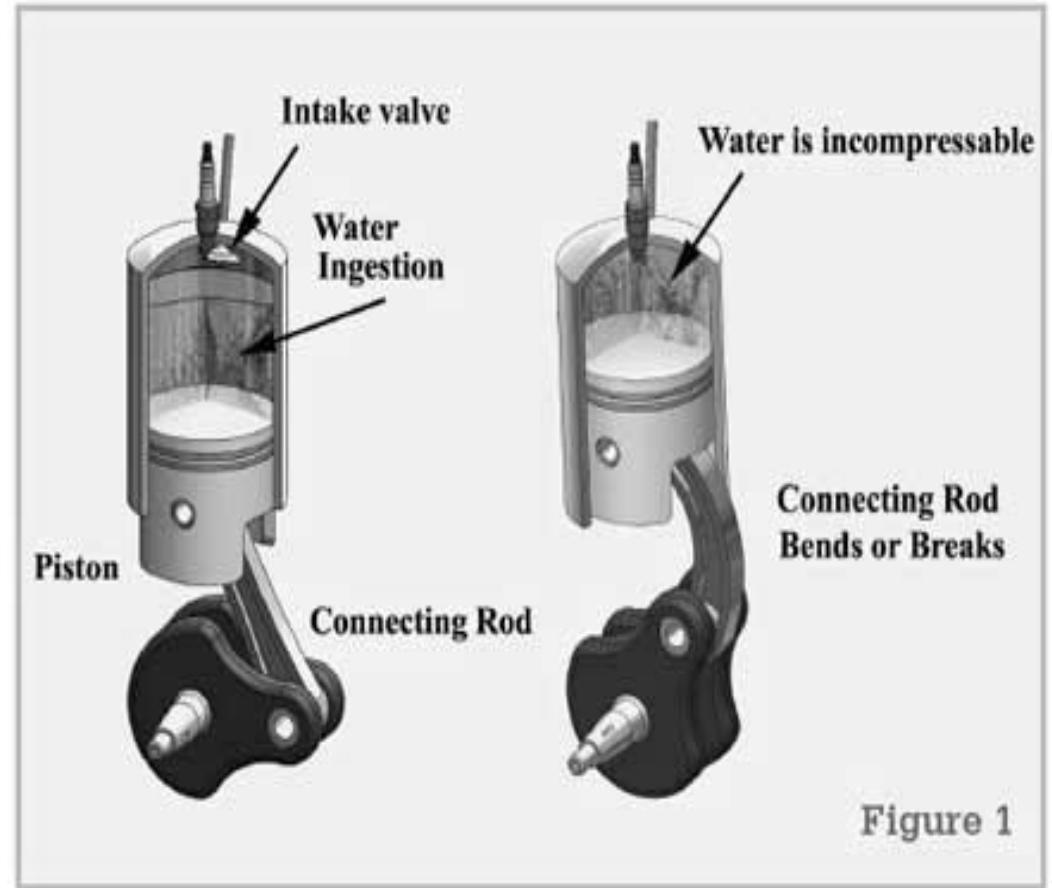
# Hydrostatic Lock

Hydrostatic lock, hydraulic lock, or hydro-lock occurs when liquids enter an engine cylinder. Liquids are incompressible; the presence of a liquid in the engine cylinder during the compression stroke generates destructively high cylinder pressures.

The left drawing shows water entering a typical automotive engine cylinder during the intake stroke.

Water, unlike the fuel/air mixture, is incompressible and, during the compression stroke, locks the piston in place as shown in the drawing at the right of Figure 1.

This condition tends to overload the connecting rod, causing a bending failure of the rod and severe engine damage.

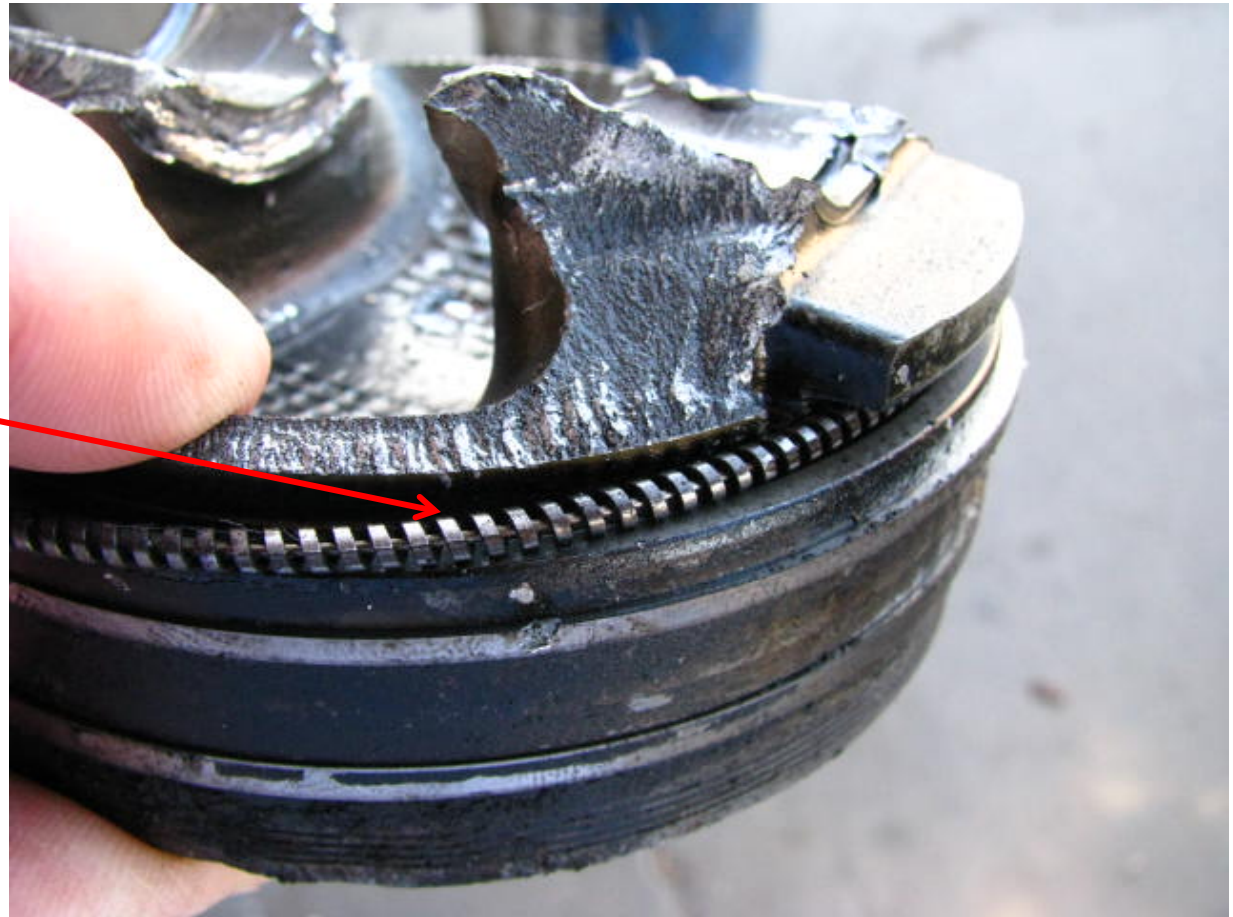
## Piston Damage – Ring Condition

Here is the main failure. This is a side view of what is left of the piston.

The ring lands, oil ring, and compression ring are fairly clean with little carbon deposits and the sides of the crown are not scored or damaged.

The bad news is we are missing 75% of the piston and there is no rod, wrist pin or keepers attached to the piston.

***Remember that this unit was DRIVEN into the shop in this condition. This piston was not moving for several miles even though the engine was running!***

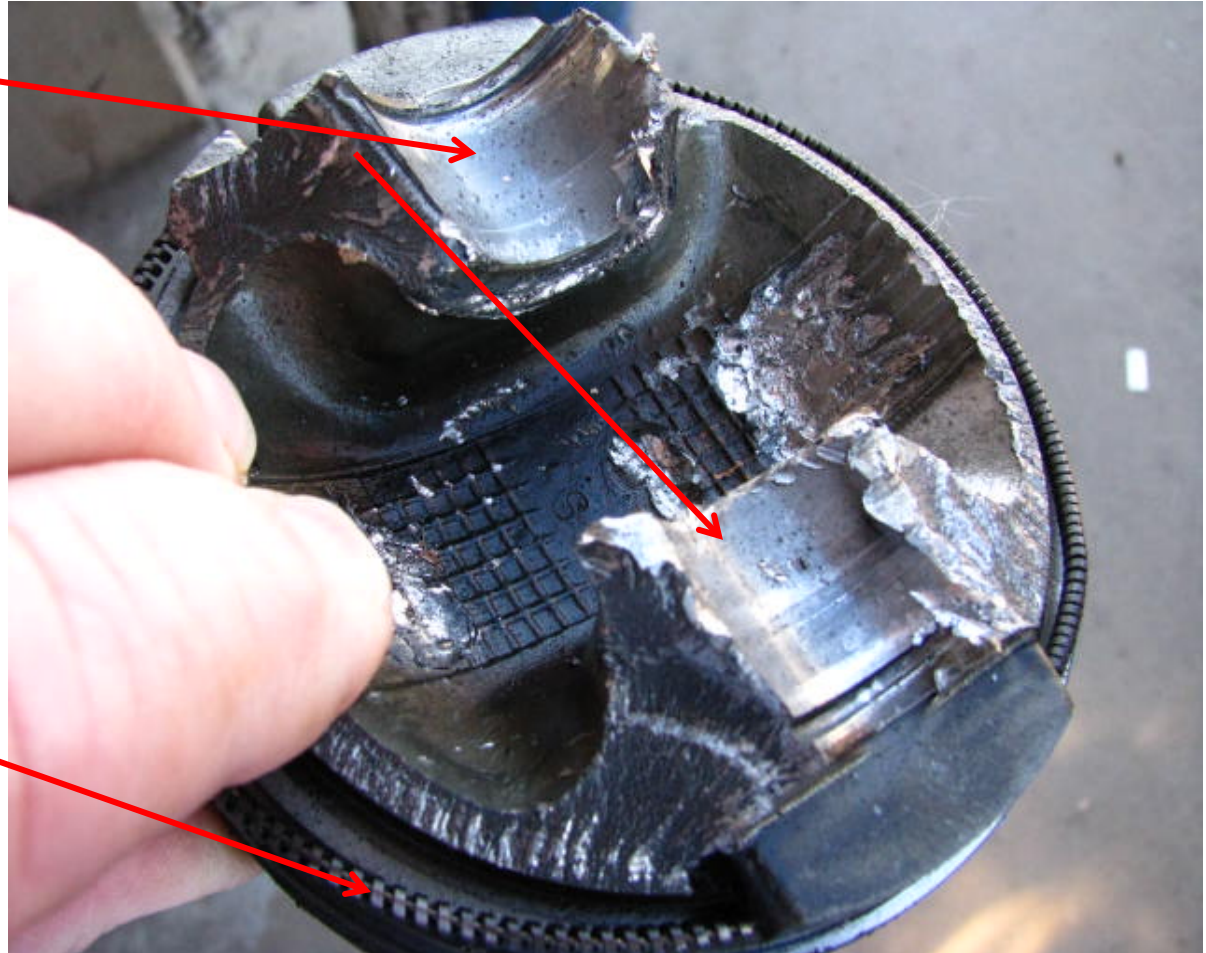
## Piston – Wrist Pin Condition

Note the condition of the **wrist pin** bearing area, still in very good shape.

The area between the wrist pin bearing areas receives a constant spray of engine oil to cool and lubricate the piston – **there is no build up in this area.**

This is a great shot to look at the area behind the oil control ring's expansion spring – very clean with **no build up of carbon.**

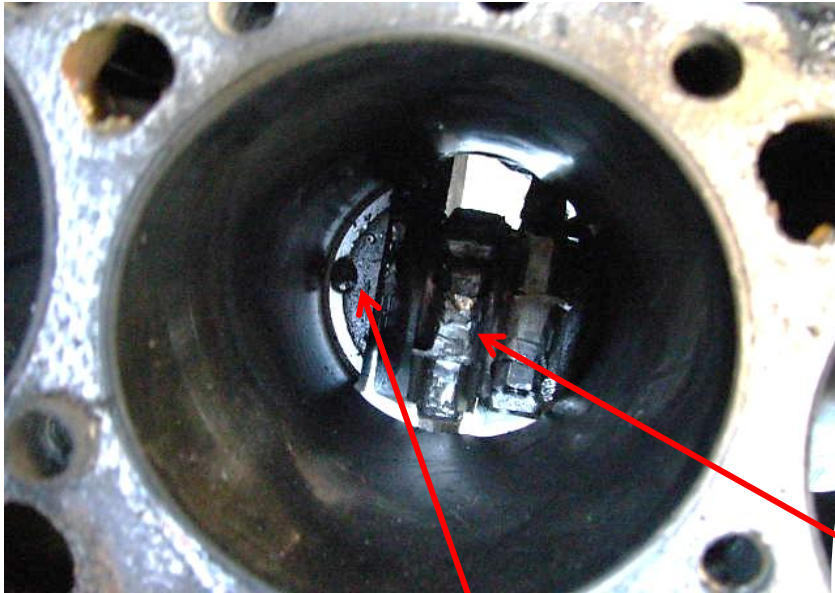
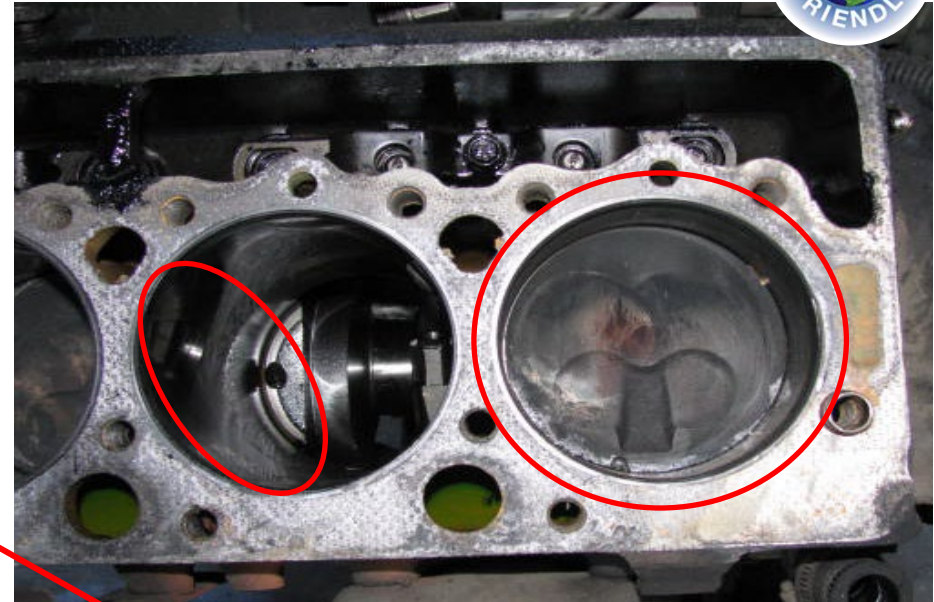
## Left Bank – Piston #5

You can see the oil **spray nozzle** and what is left of the **connecting rod**. The **cylinder walls** are still in good shape, considering what it has went through.

Cylinder walls / perfect condition, very little carbon build up above top compression ring contact area. Top of pistons very clean, very little carbon, burning extremely clean (right bank side) crank area for connecting rod clean, smooth and in great shape.

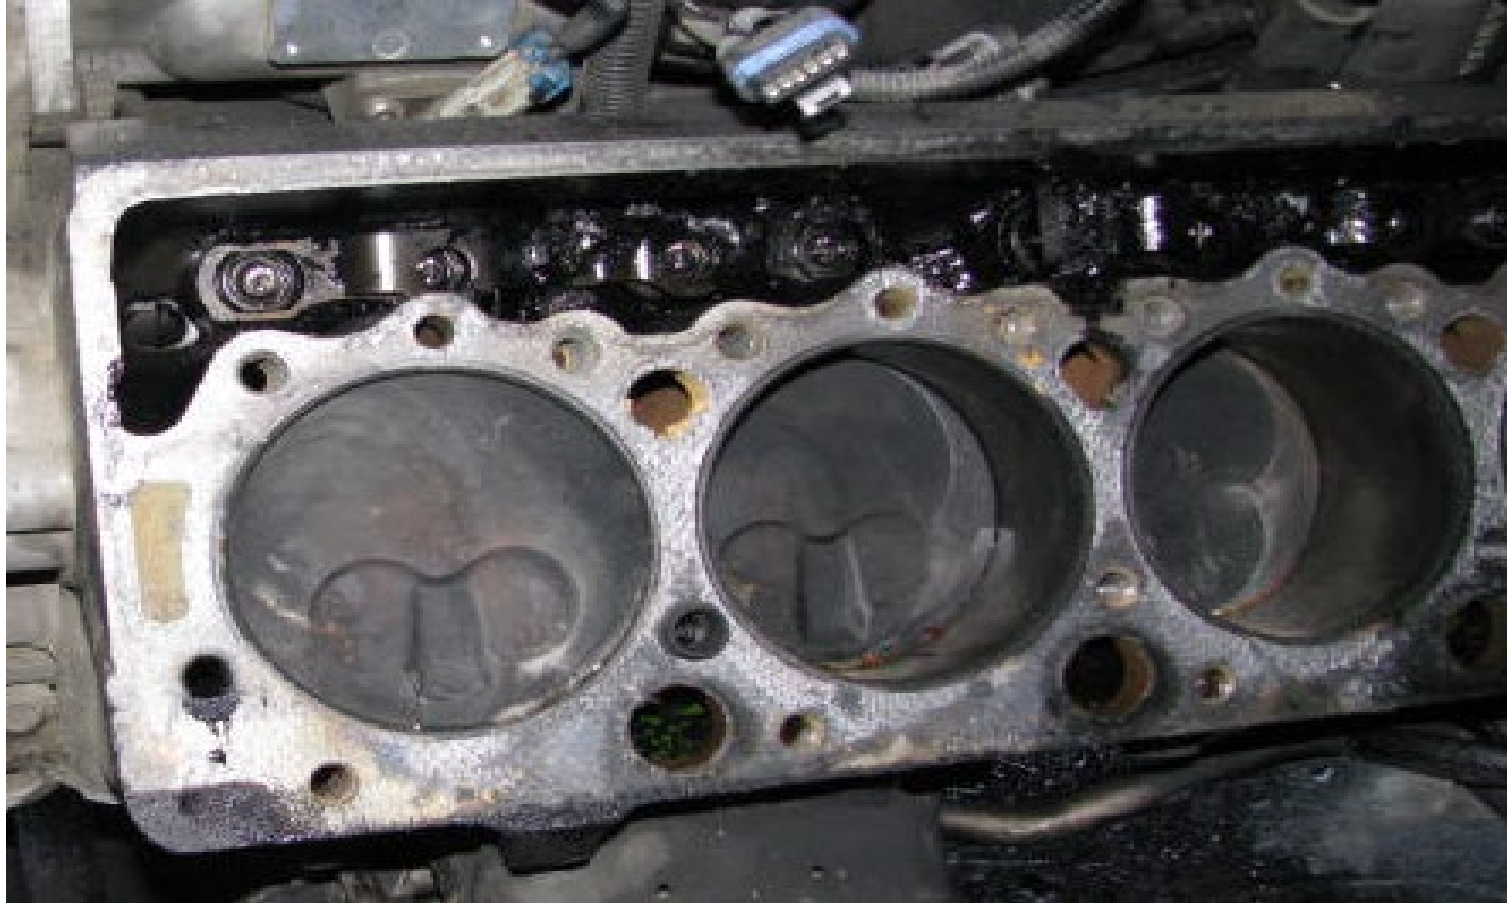
# Cylinder Head – Left Bank

Same results on (left bank) cylinders, very clean burning, extremely low carbon deposits on top of pistons, cylinder walls in excellent shape – we have already discussed the condition of engine oil you can see in the lifter valley.

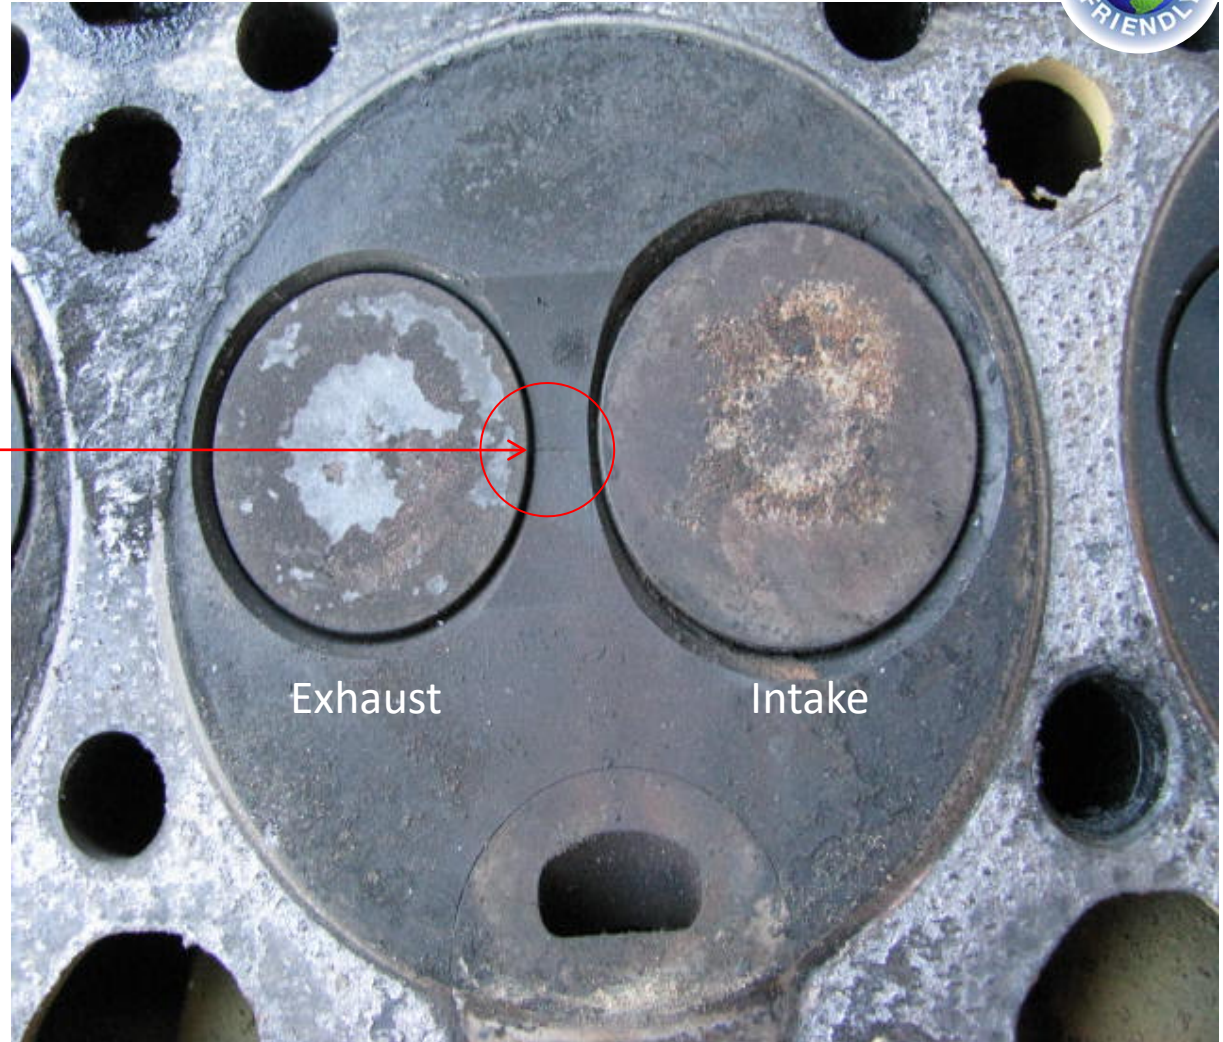
Close up of intake and exhaust valve, fire deck surface on cylinder head.

Note the crack between the valves – we will discuss this in a couple of slides.

**Extremely low carbon build up** on valves, fire deck surfaces and combustion chamber.

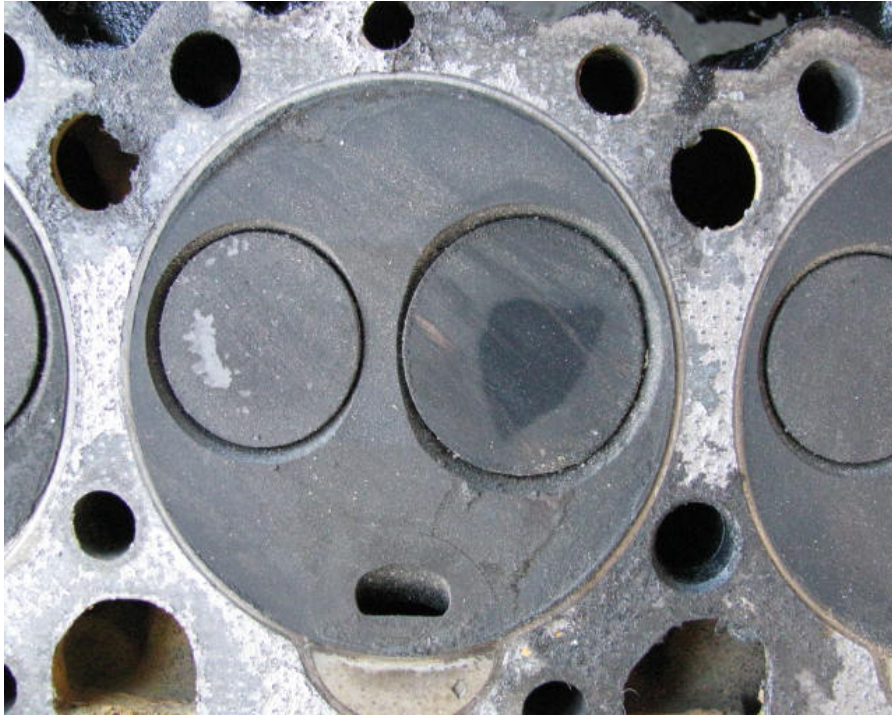
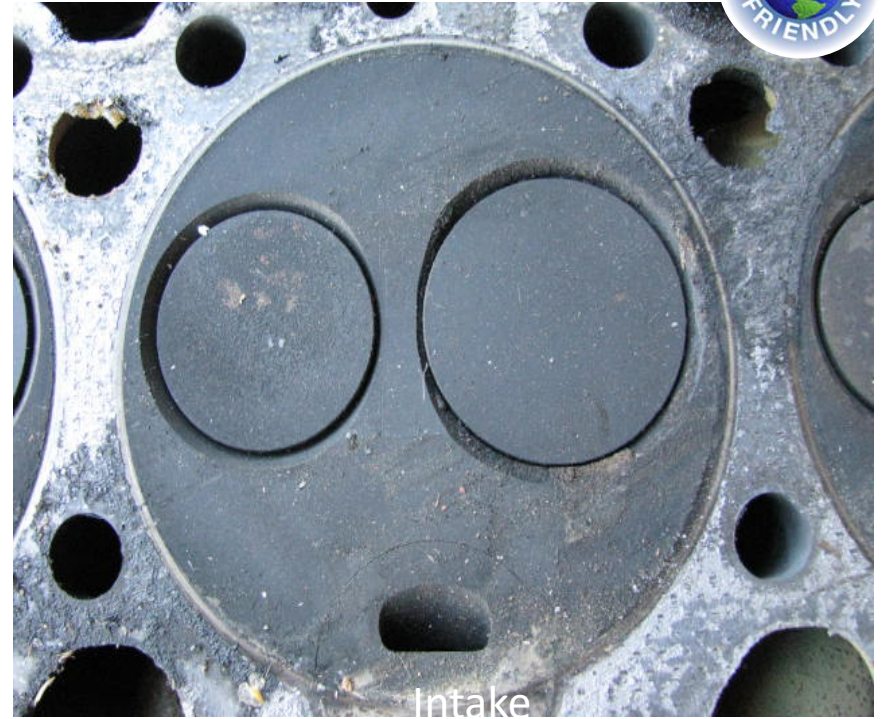
This is another close-up of more cylinders, please examine the low build up of carbon deposits on valves and fire deck surfaces.

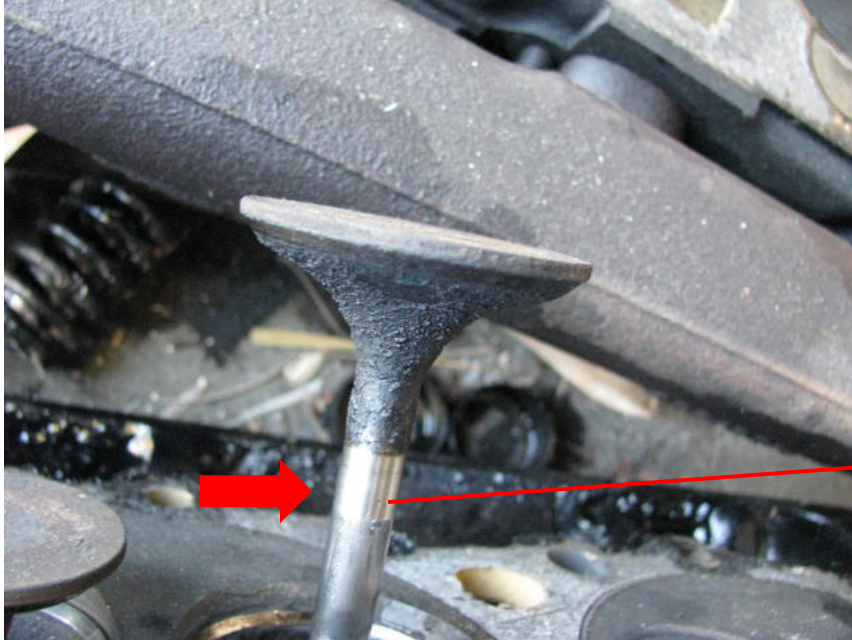
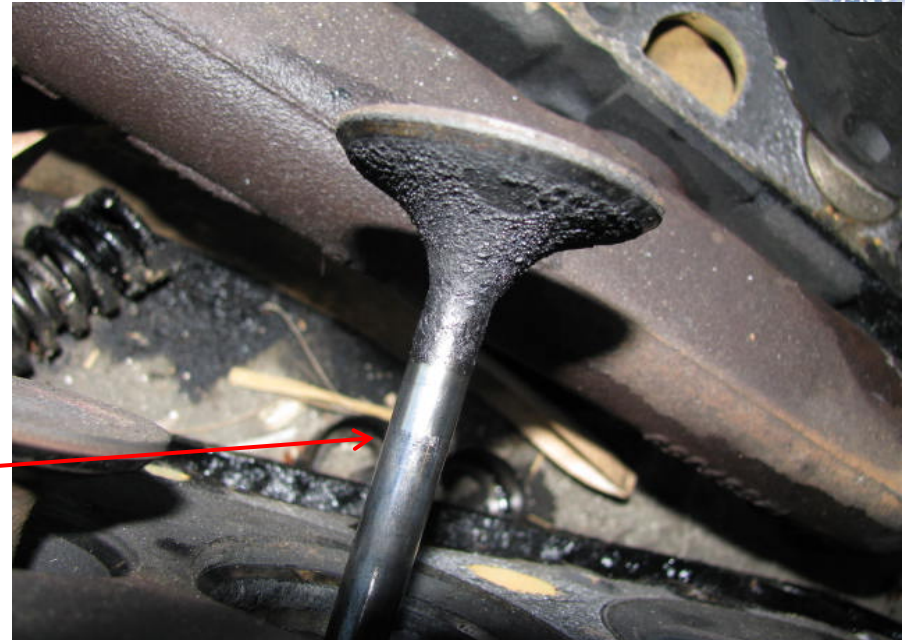
This is a close-up of an intake valve out of the right bank cylinder head. Very little carbon build up on the valve head – Please note there is NO carbon or oil build up on valve stem. Very impressive....

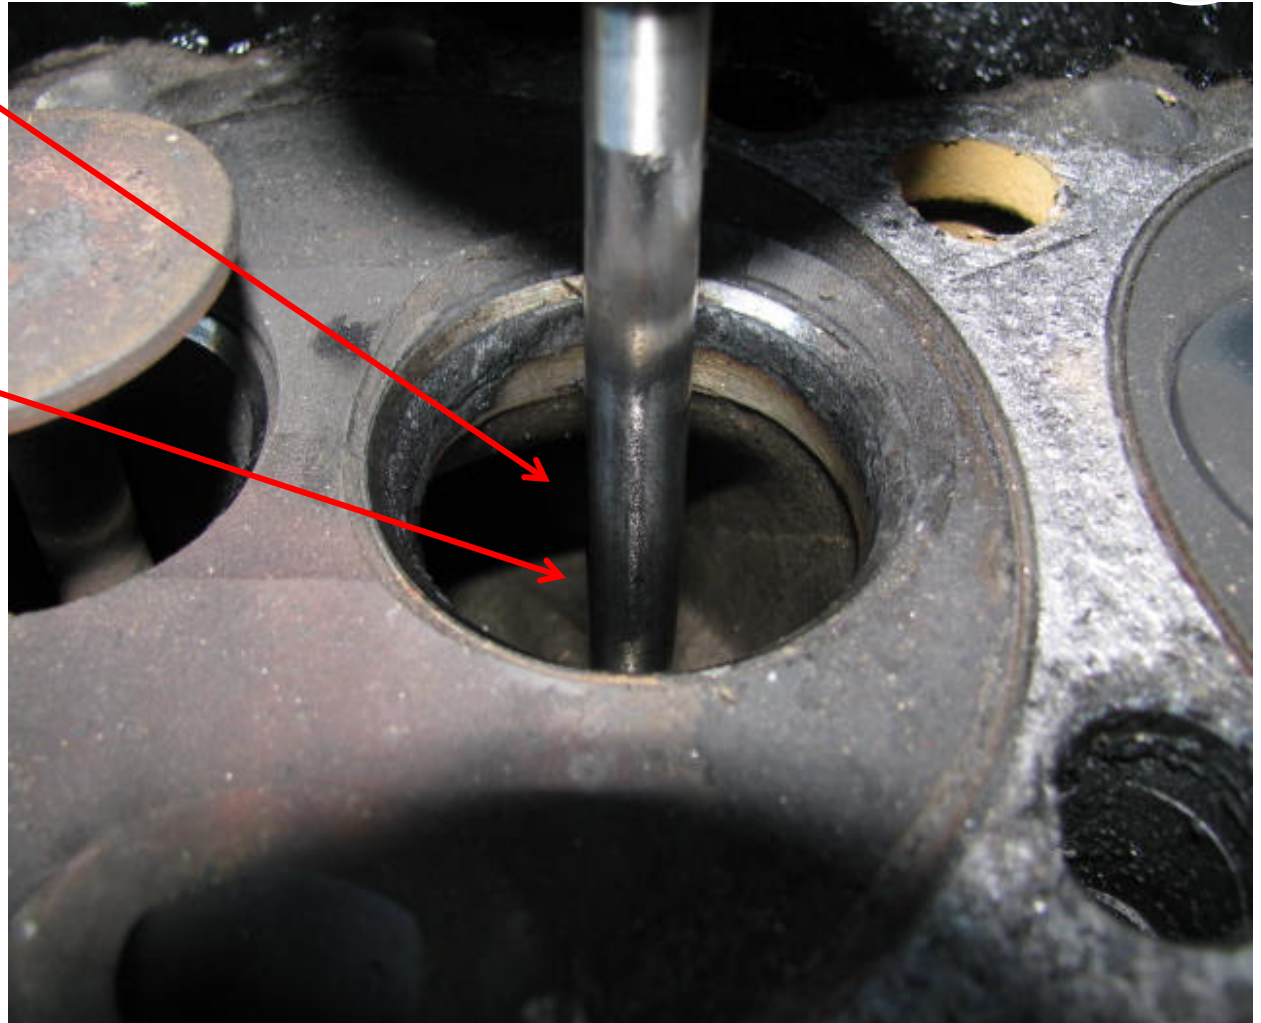
# Valve Stem – No Carbon

Close up of the **intake chamber** of an intake valve, there is basically no carbon build up to notice.

**Valve stem** is unbelievably clean, no carbon, “coke” build up (cooked on oil) in the valve guide area.

Valve seals are obviously in great shape on this engine, or the stem would have oil and carbon deposits on it.

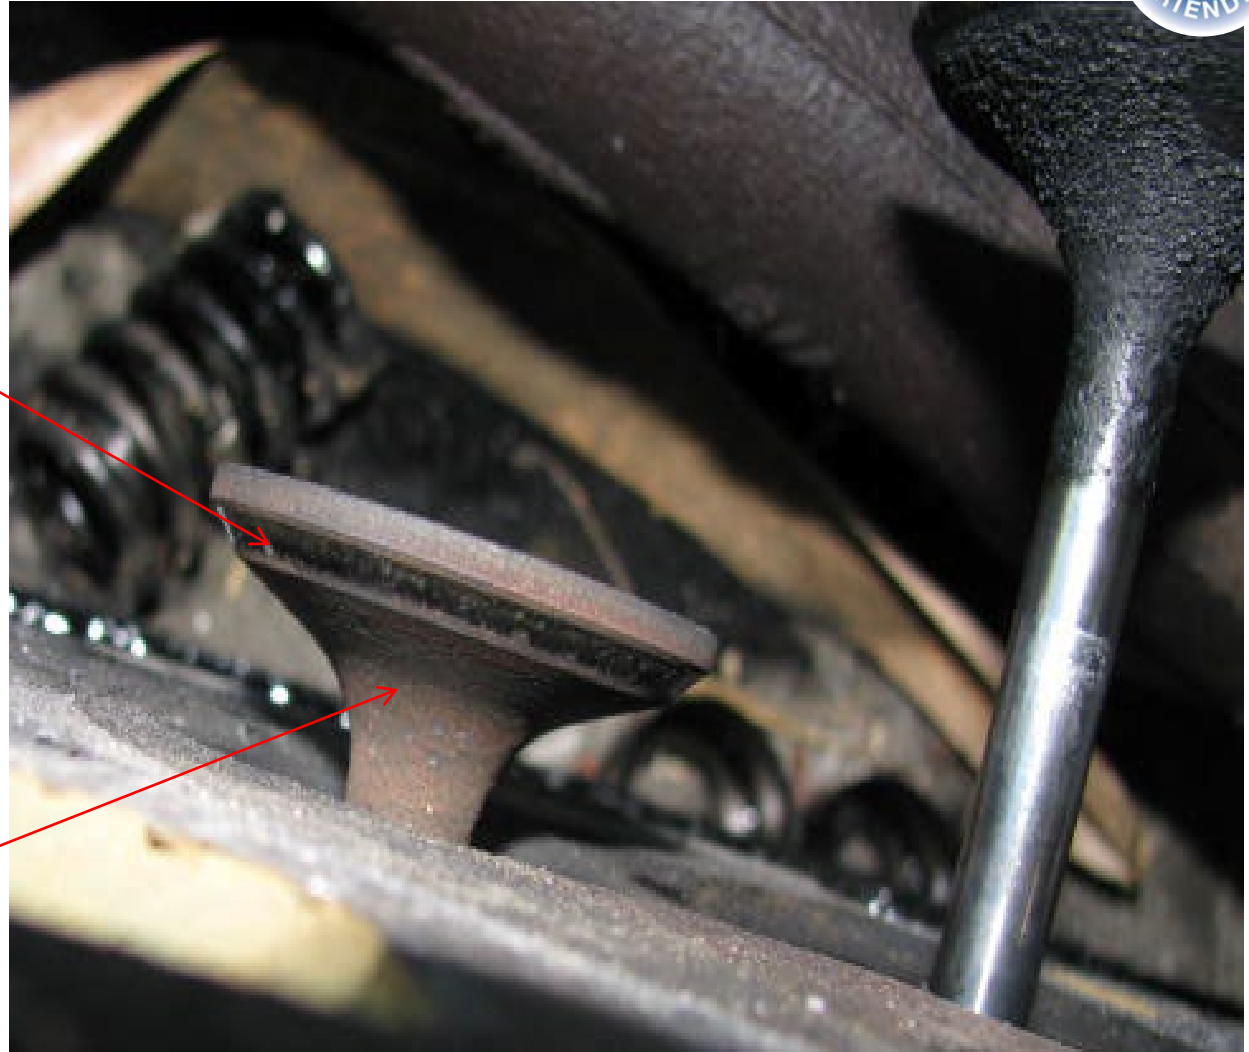
This is a close up on one of the exhaust valve seating / sealing area and the bottom of the valve face.

There is basically no carbon on this valve, you can plainly see that the fuel mixture on this engine is burning very well – no build up on the exhaust valve .

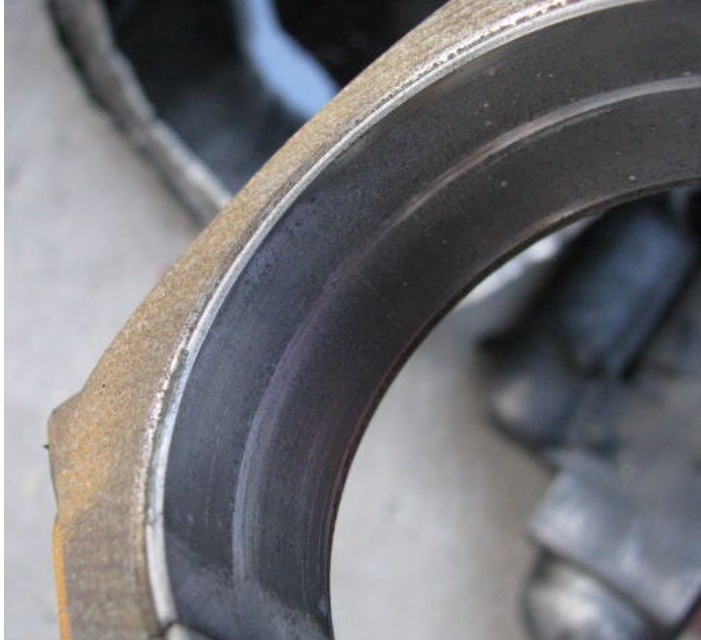
A close up of one of the rod bearings on this engine reveals extremely minimal wear to speak of. The wall thickness clearly shows a very usable bearing with a lot of miles left on it.

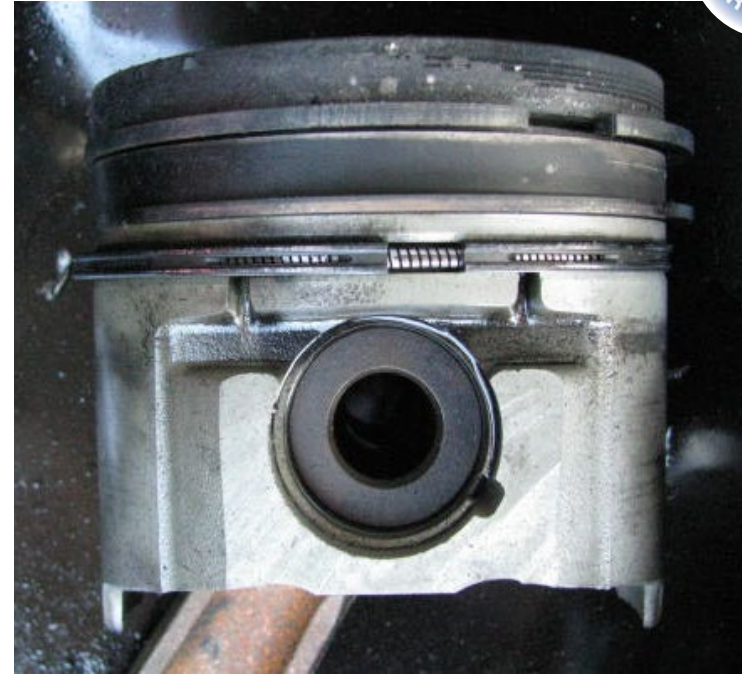
Here is a piston out of this engine, look at the oil control ring (bottom ring) and the expander (spring under the oil control ring). There is no carbon or “coking” in this area. There is very little carbon build up anywhere on this piston.

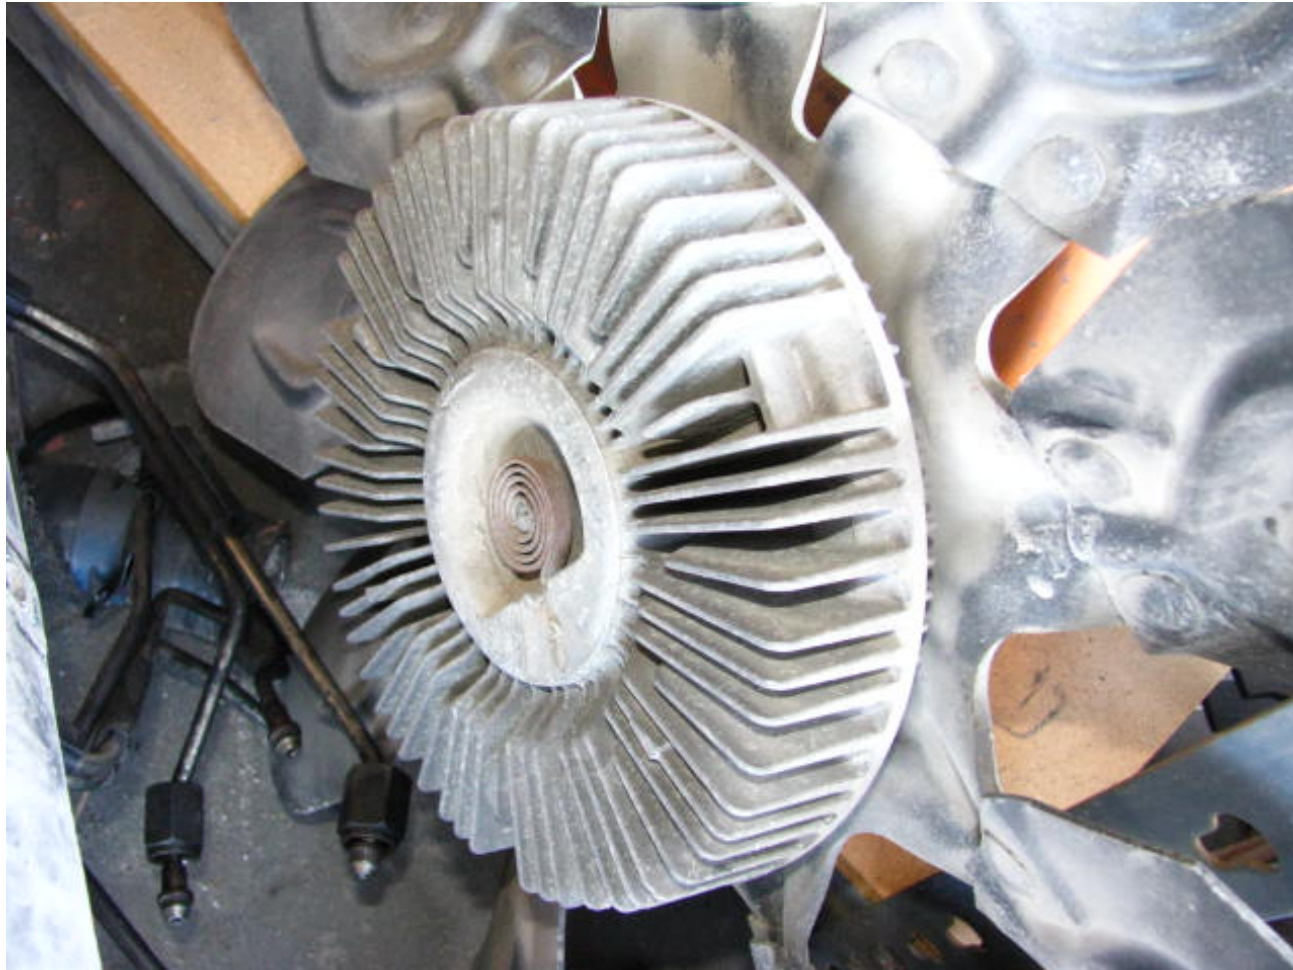
**Here is the cause of engine failure**  
**\$95.00 in parts // 1 hour labor**  
**DEFECTIVE FAN CLUTCH**
