# Introduction

This a Case Study where one of their vehicles was driven in with a “Runs Rough” complaint. Which after further inspection, turned out to be more catastrophic than anticipated.

# Cylinder Head Crack

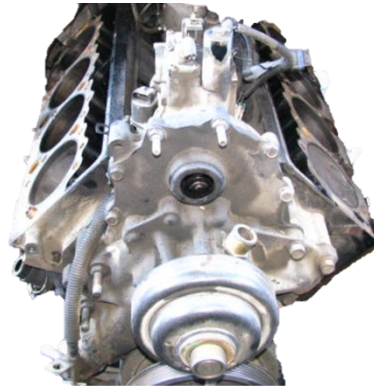
Core Charge

Your replacement engine just got about more expensive due to no core credit. That’s \$3,000 plus another \$3,000 you will be charged for not providing a rebuildable core.

As the antifreeze and water congealed with the engine oil, **ProOne** kept the lubrication film from breaking down. This is evident as we review the condition of the piston ring lands, piston skirts, cylinder walls, rod bearings and valve stems. This engine still qualifies for at least 80% core return dollars
